DEPARTMENT OF TRANSPORTATION**DIVISION OF ENGINEERING SERVICES**

Contract #: 04-0120F4Cty: SF/ALA Rte: 80 PM: 13.2/13.9File #: 99.28**WELDING INSPECTION REPORT****Resident Engineer:**Siegenthaler, Peter**Address:** 333 Burma Road**City:** Oakland, CA 94607**Report No:** WIR-022595**Date Inspected:** 15-Apr-2011**Project Name:** SAS Superstructure**OSM Arrival Time:** 700**Prime Contractor:** American Bridge/Fluor Enterprises, a JV**OSM Departure Time:** 1900**Contractor:** Zhenhua Port Machinery Company, Ltd (ZPMC) Chanxing Island**Location:** Shanghai, China**CWI Name:** Mr. Liu Hua Jie**CWI Present:** Yes No**Inspected CWI report:** Yes No N/A**Rod Oven in Use:** Yes No N/A**Electrode to specification:** Yes No N/A**Weld Procedures Followed:** Yes No N/A**Qualified Welders:** Yes No N/A**Verified Joint Fit-up:** Yes No N/A**Approved Drawings:** Yes No N/A**Approved WPS:** Yes No N/A**Delayed / Cancelled:** Yes No N/A**Bridge No:** 34-0006**Component:** OBG Segment**Summary of Items Observed:**

WELDING INSPECTION REPORT

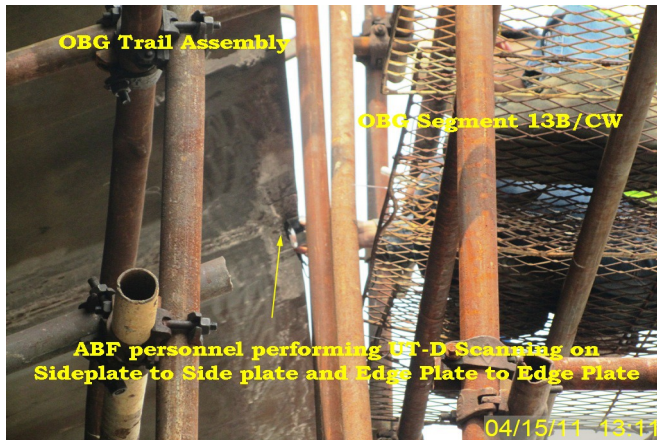
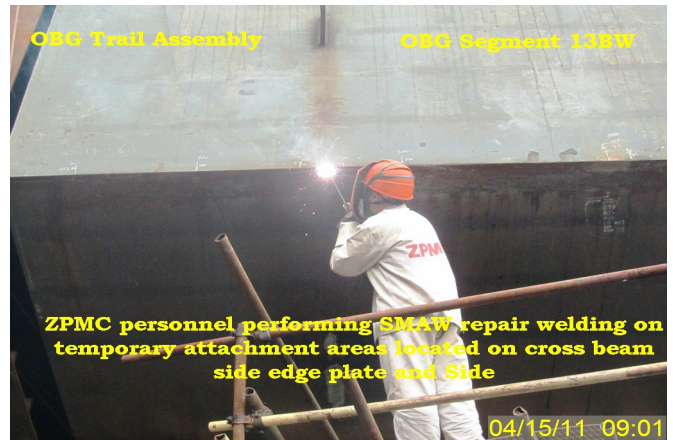
This QA inspector observed ABF personnel performed Ultrasonic Testing (UT) on Deck Panel to Deck Panel of OBG Segment 13BW to 13CW. See the attached picture.
